Leak Detection & Repair

COMMONWEALTH UTILITIES CORPORATION WATER DIVISION

Leak Detection and Repair Phase II

Leak Detection and Repair – Phase II

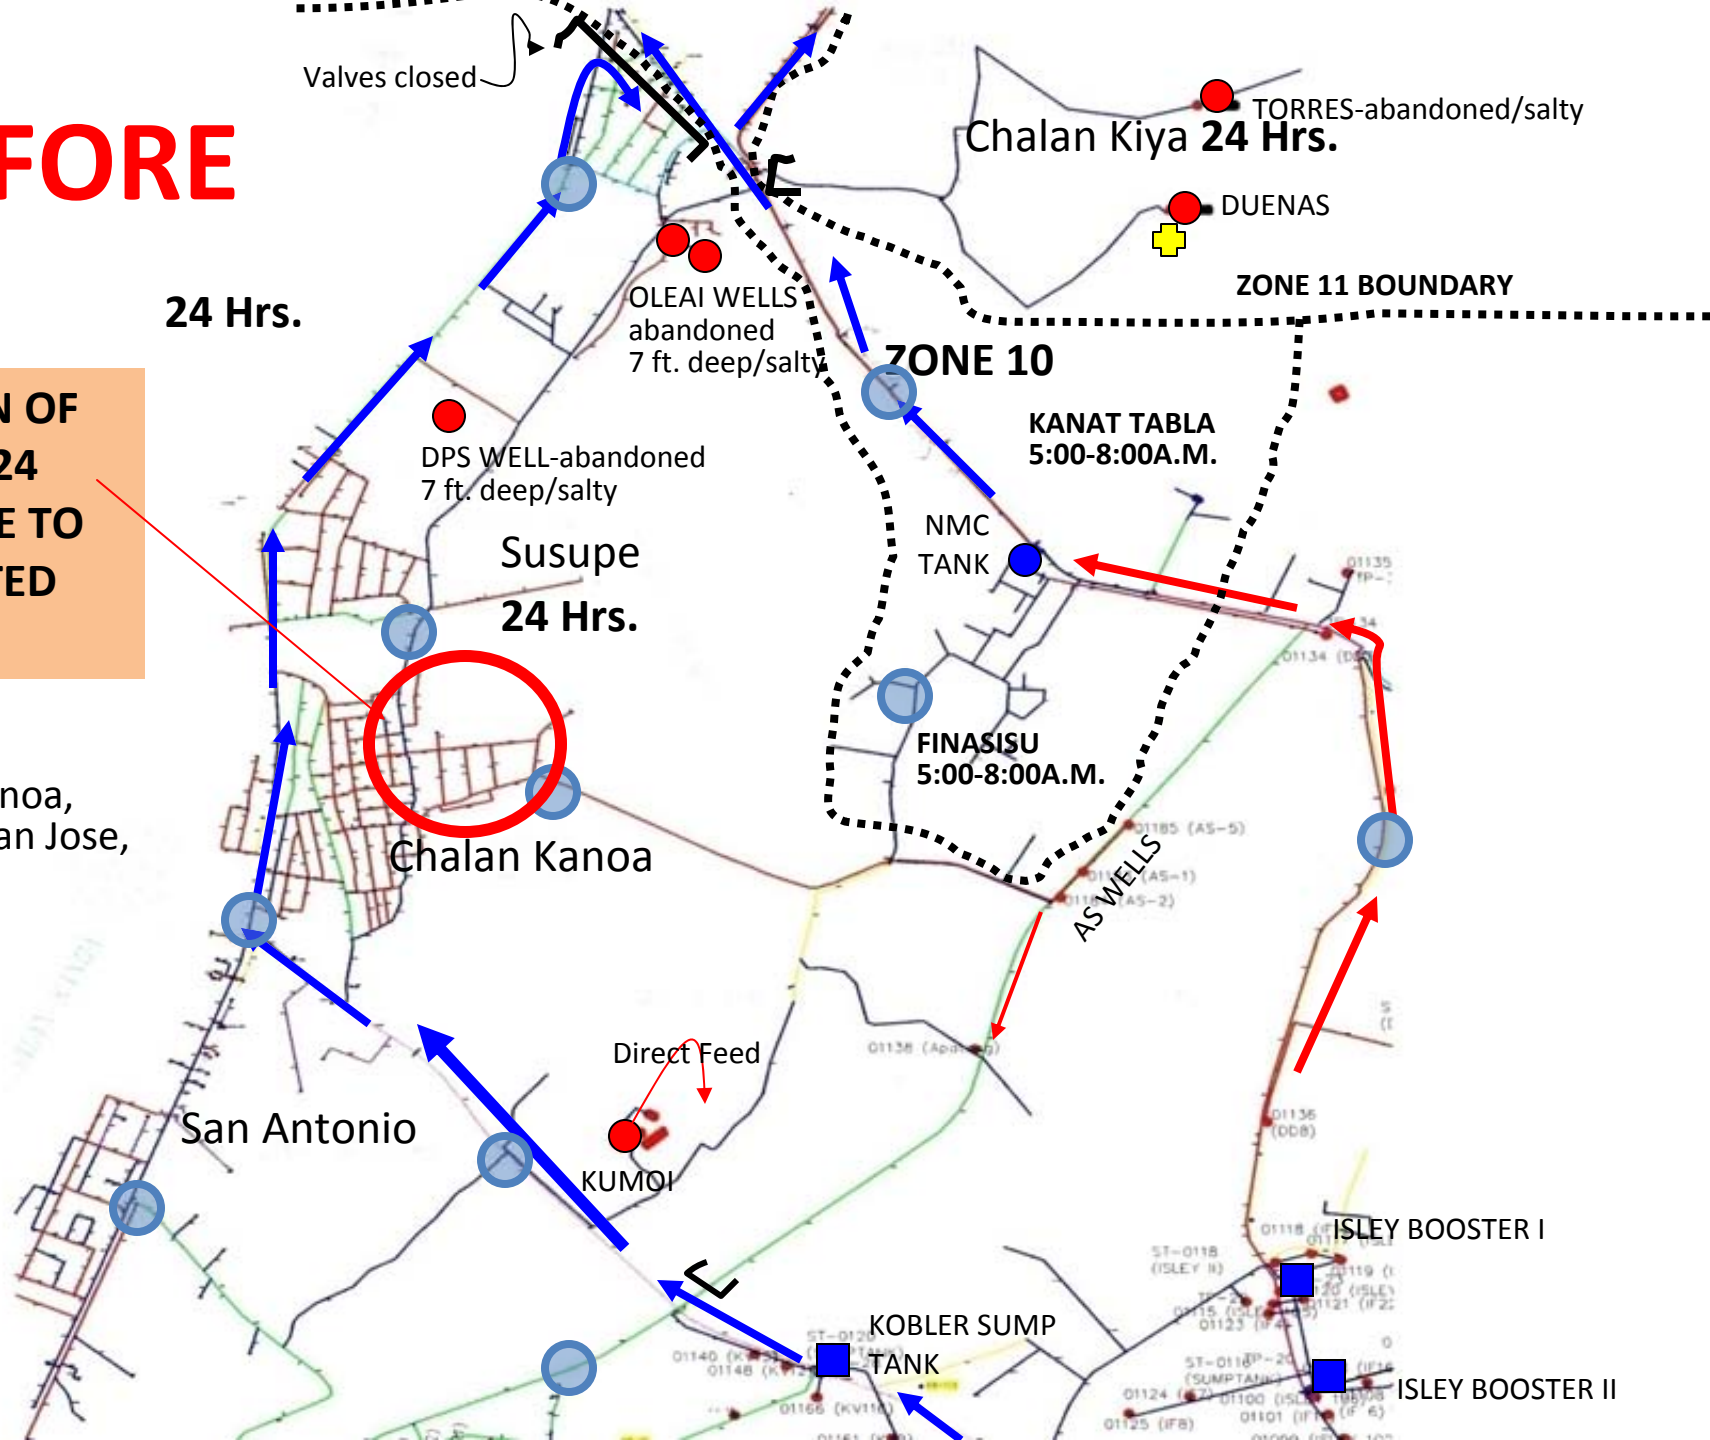
ZONE 9a
Chalan Kanoa, Susupe, San Jose, Oleai

PORCION OF CK NOT 24 HRS. DUE TO SUSPECTED LEAKS

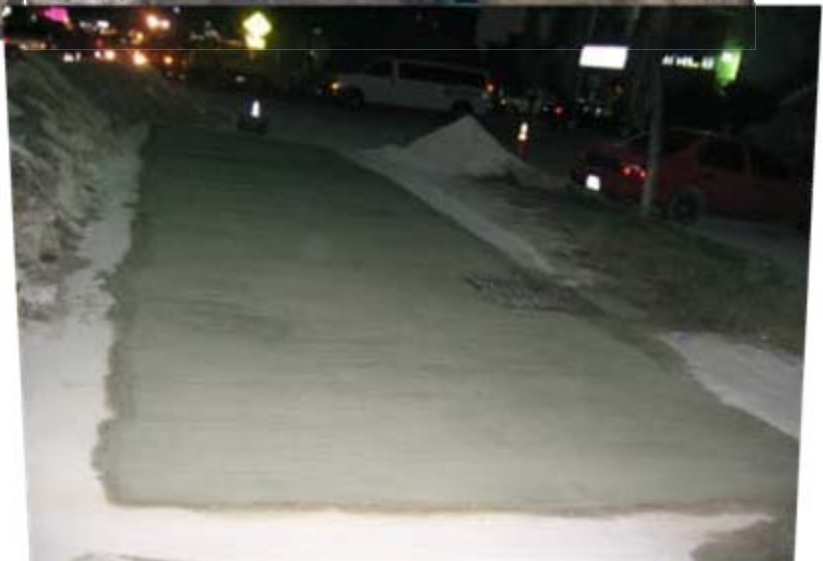
Chalan Kanoa

Leak Repair – 12" Ø PVC

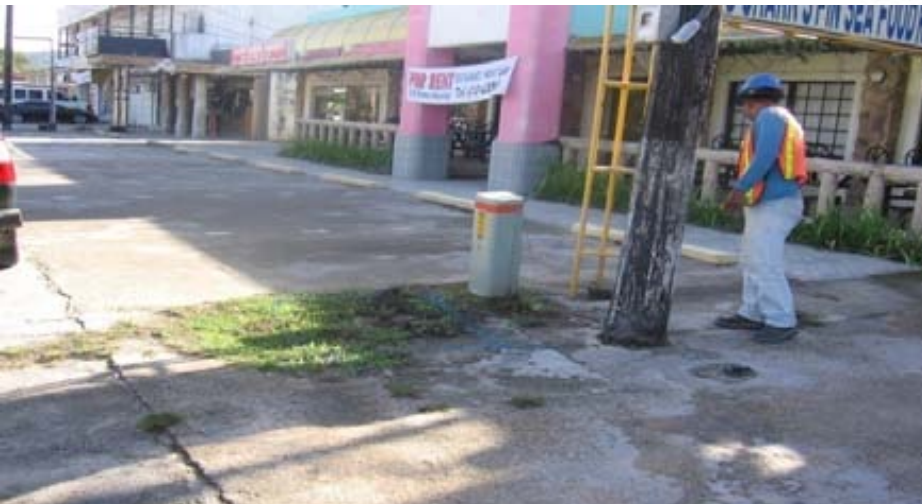
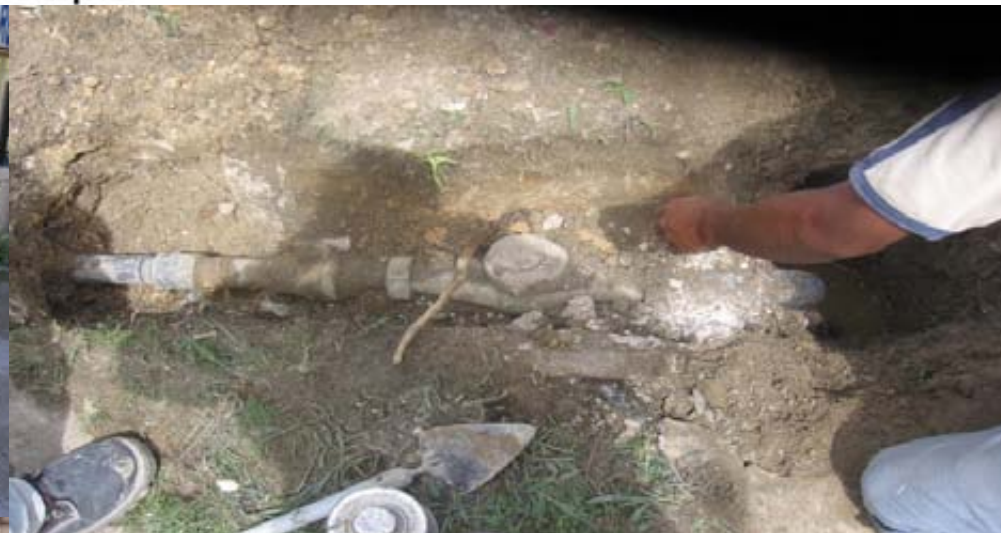
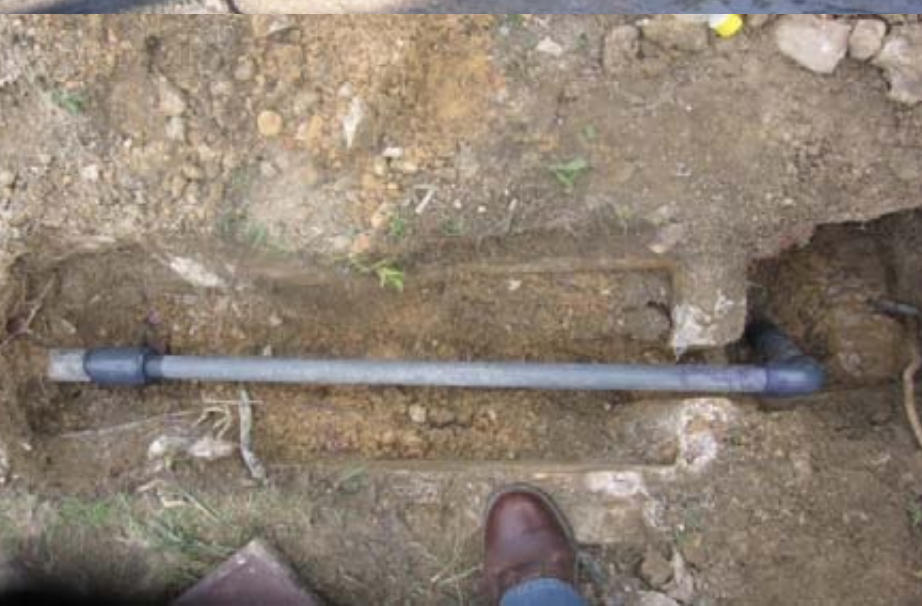
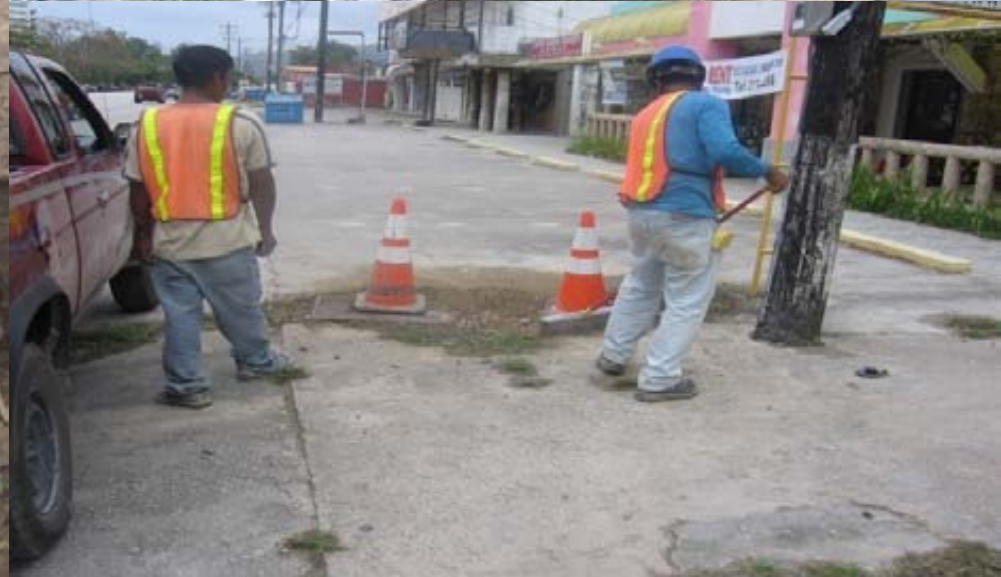
Susupe

Leak Repair –2" x 1-1/4" dia PVC

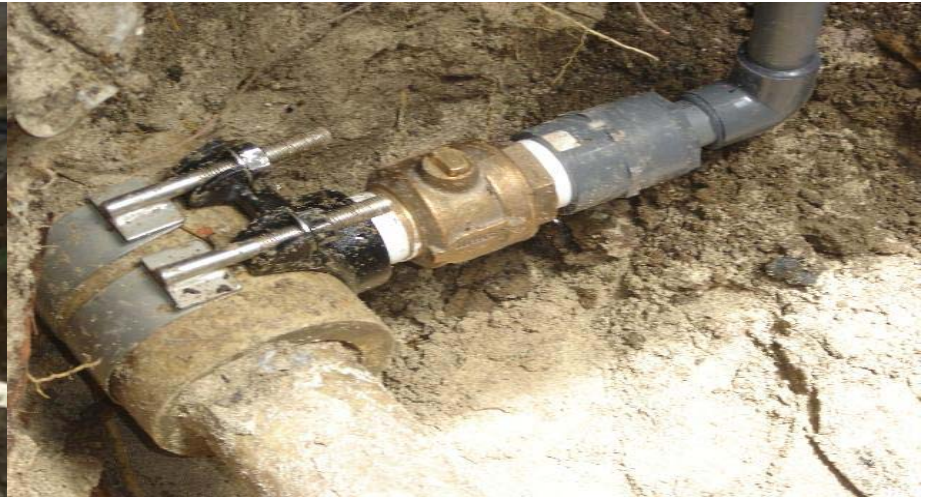
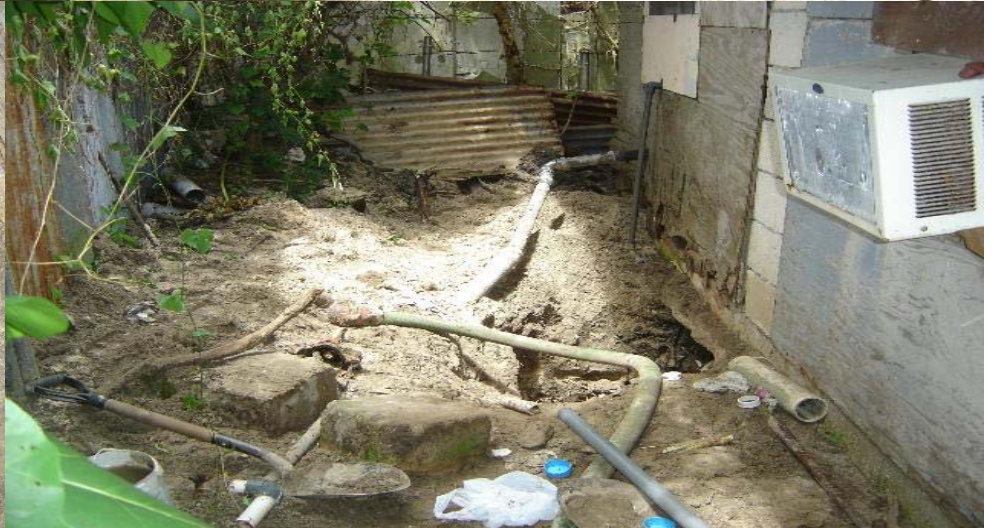
Leak Repair –6" x 2" Service Saddle and 2" Corporation Stop
San Antonio

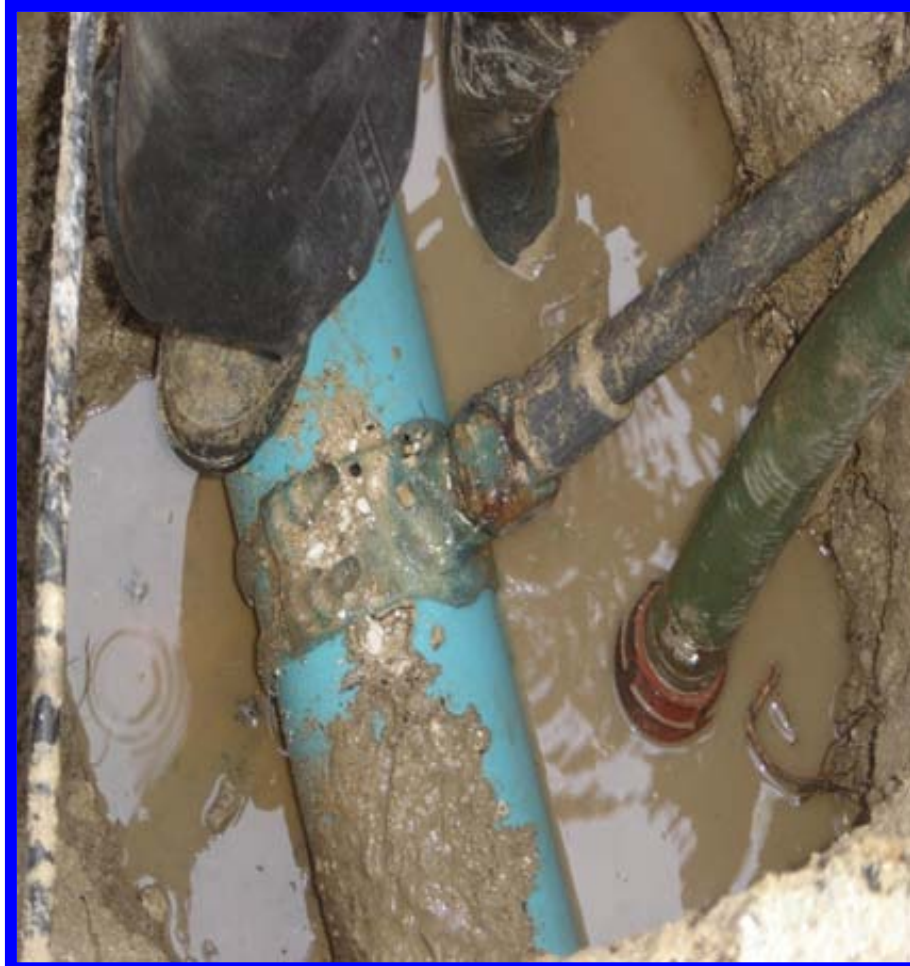
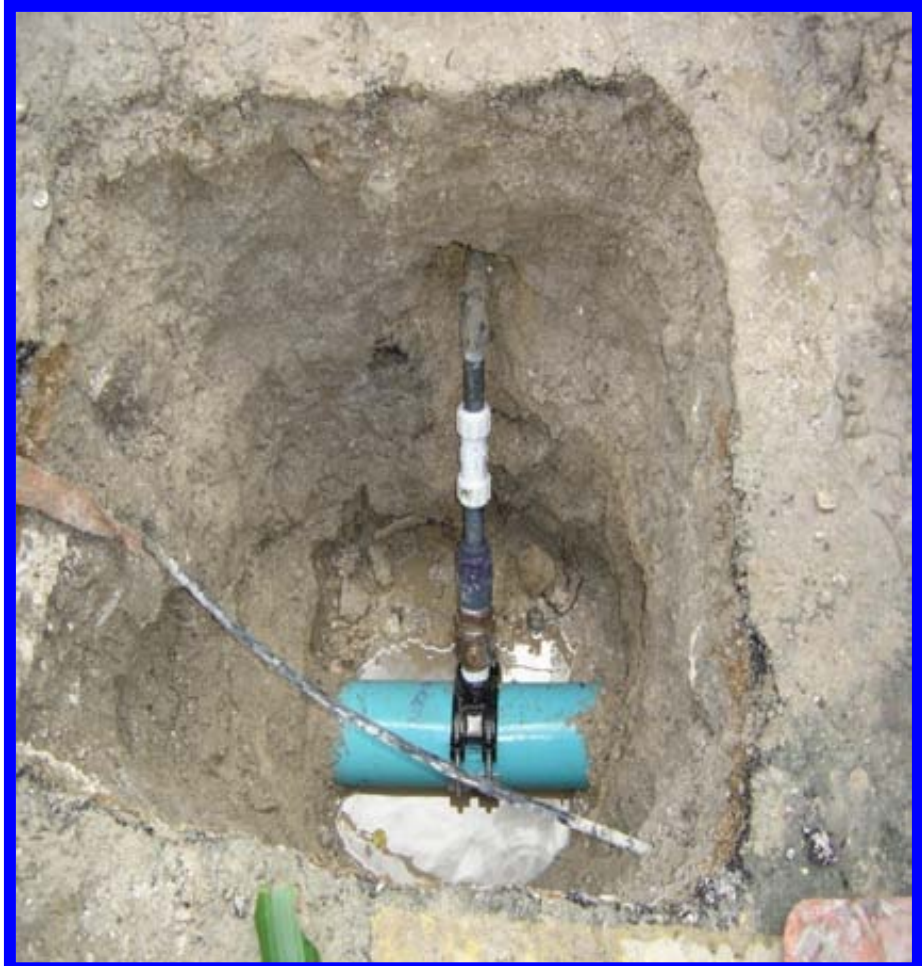
Leak Repair – 6" x 2" Service Saddle and 2" Corporation Stop
Chalan Kanoa

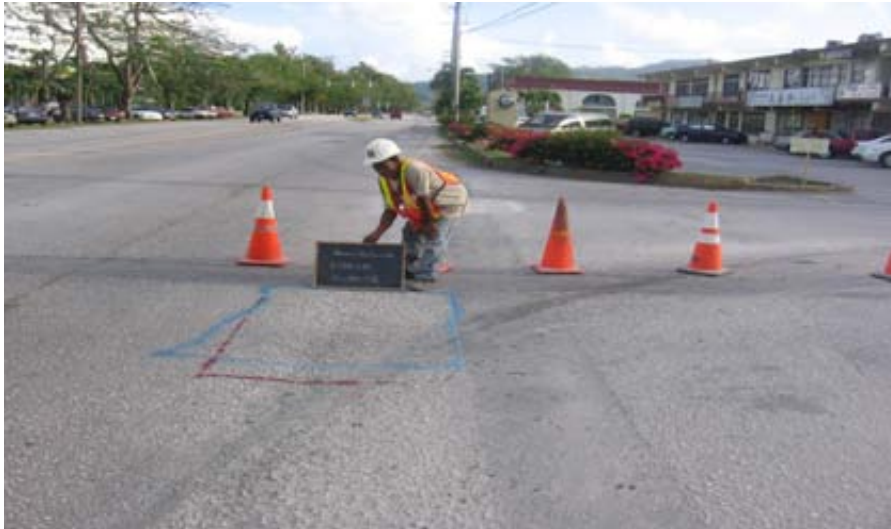
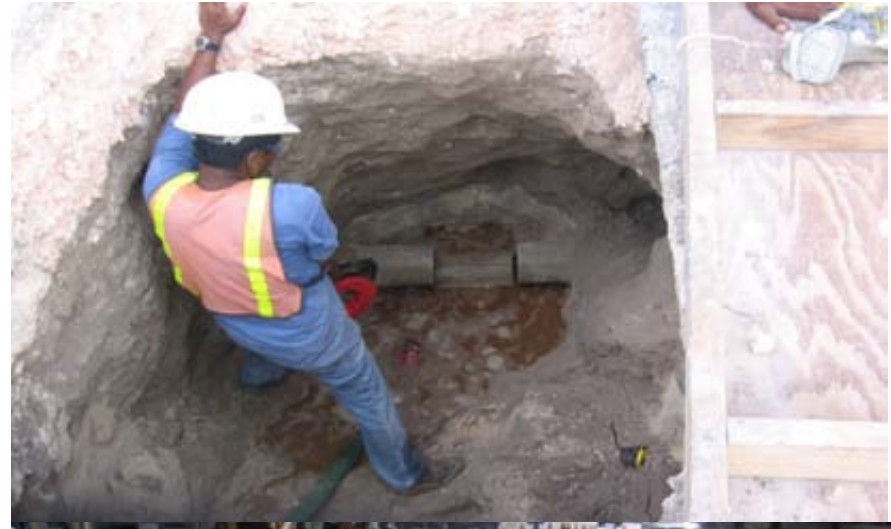
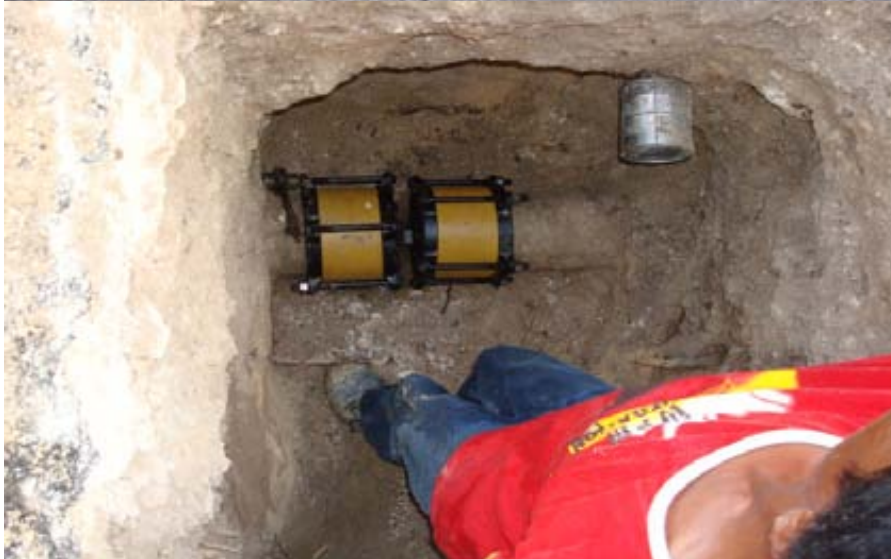
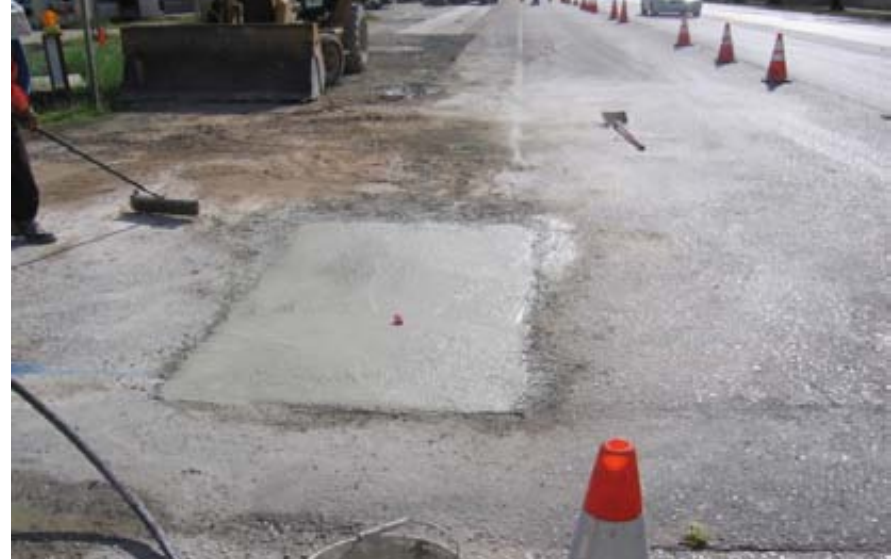
Susupe

Cut & Cap –6" ACP

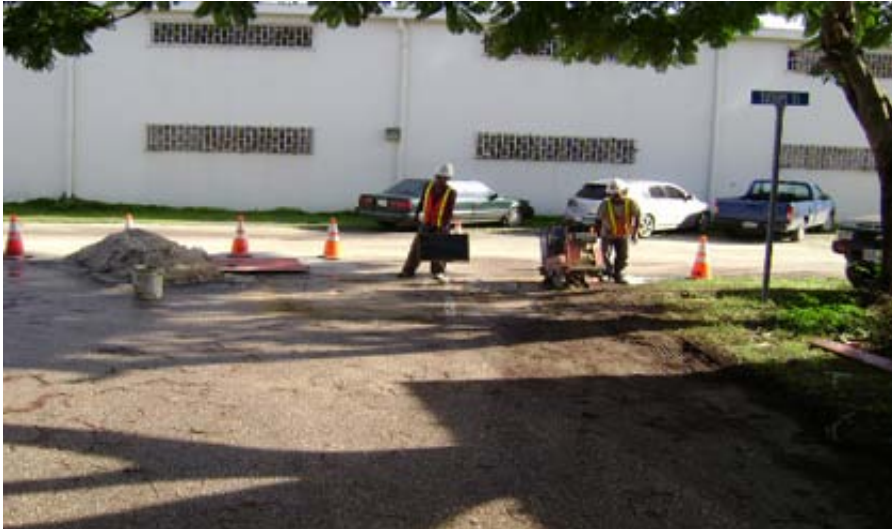
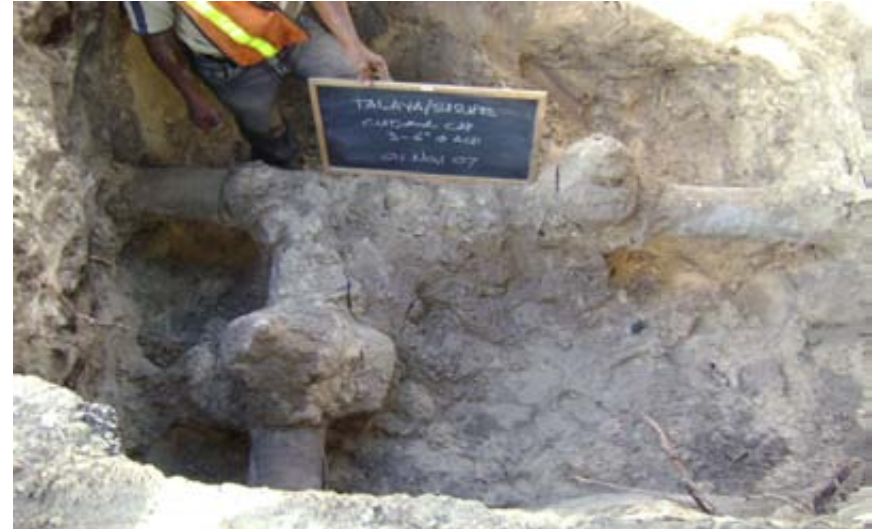
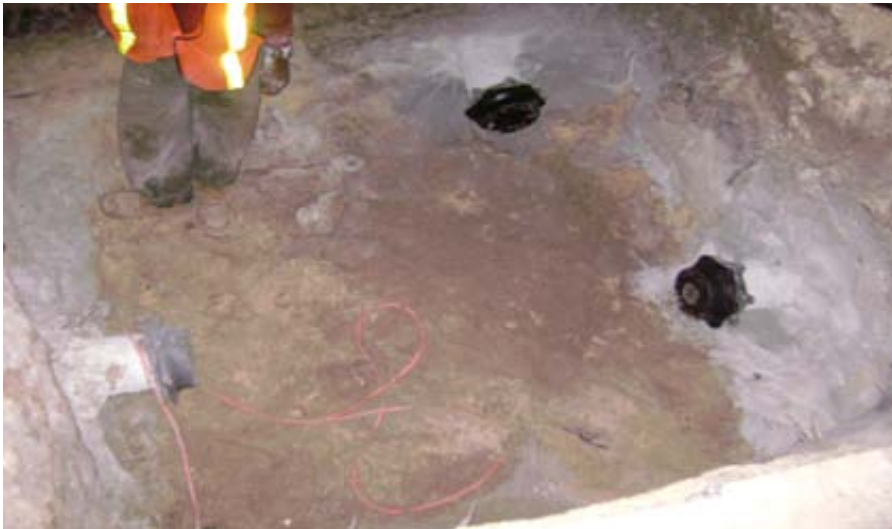
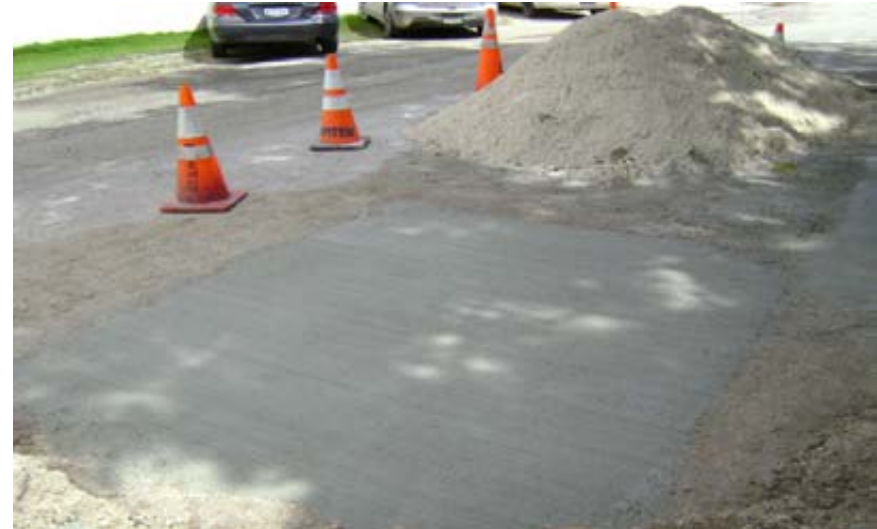
Susupe

Cut & Cap 6" ACP

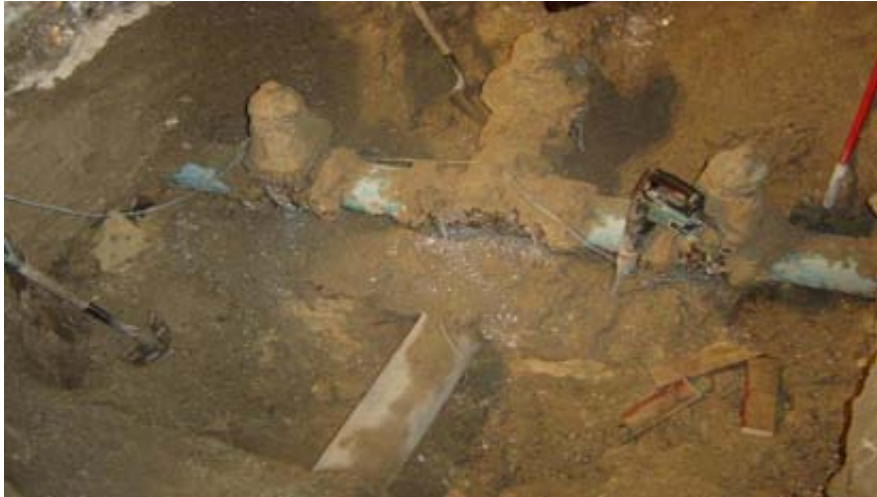
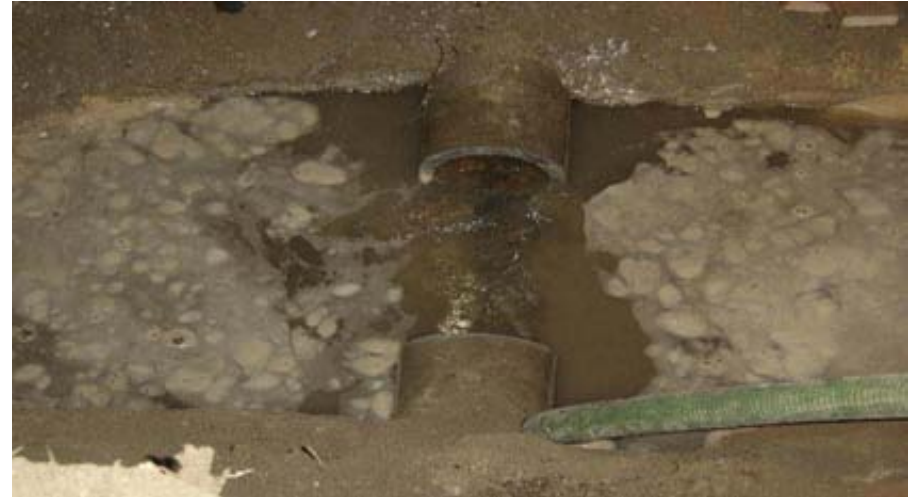
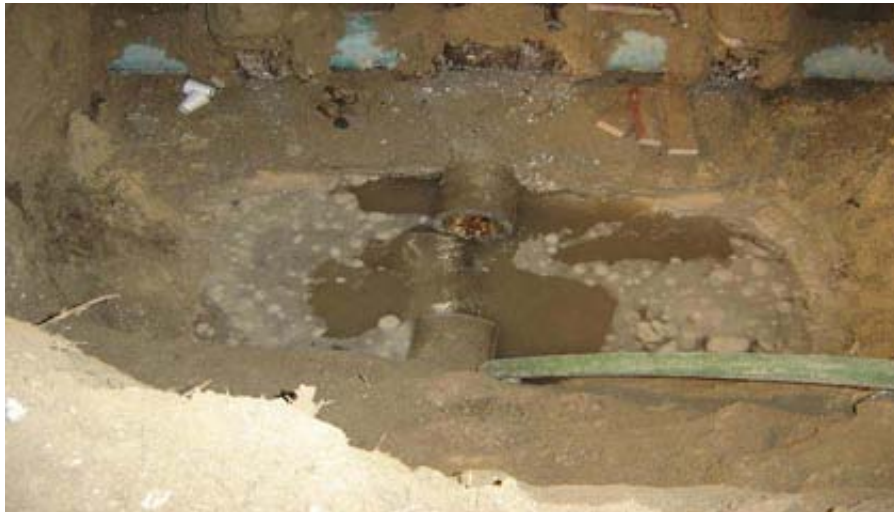
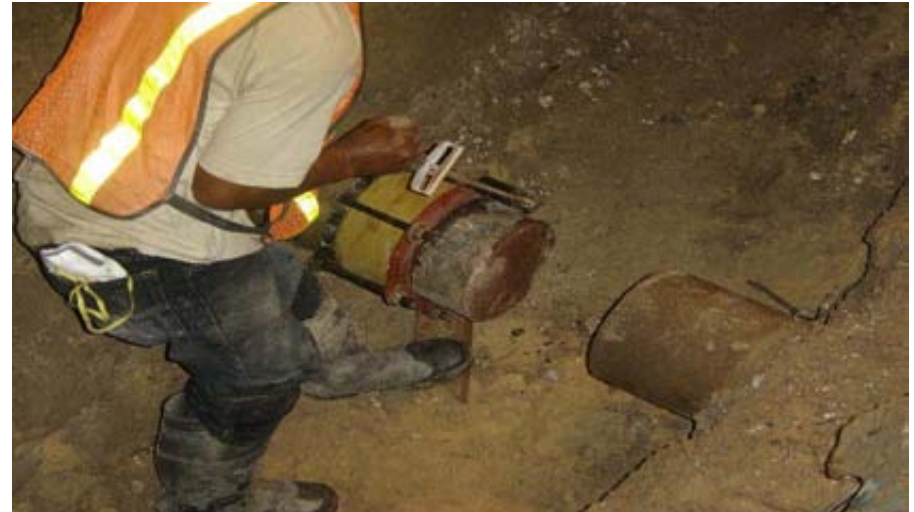
Chalan Kanoa

Cut & Cap – Undocumented Lines

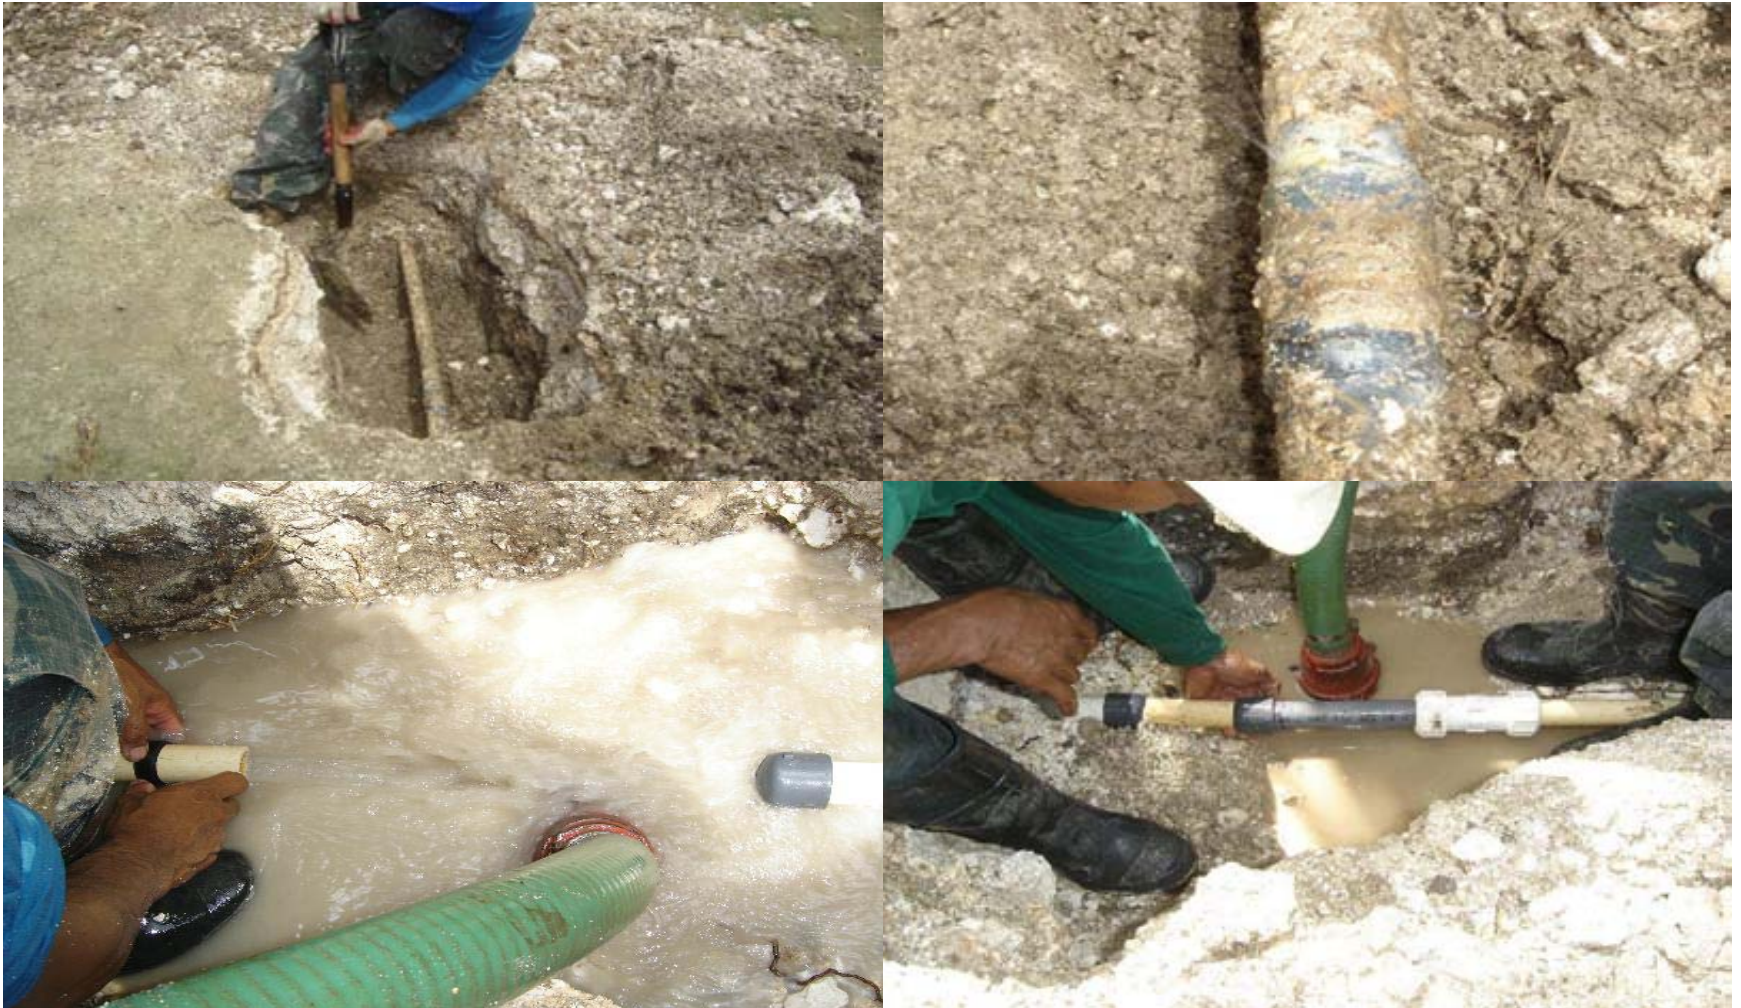
Cut & Cap – Undocumented Lines
San Antonio, Across from PIC

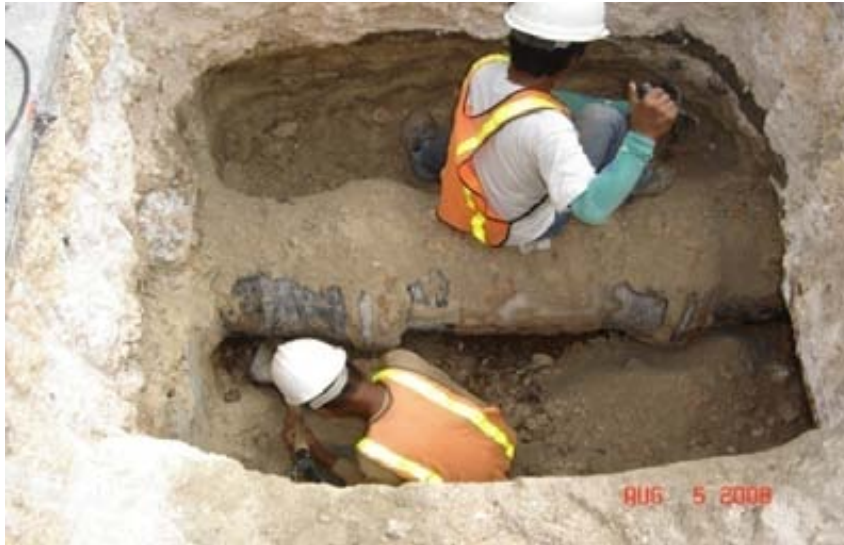
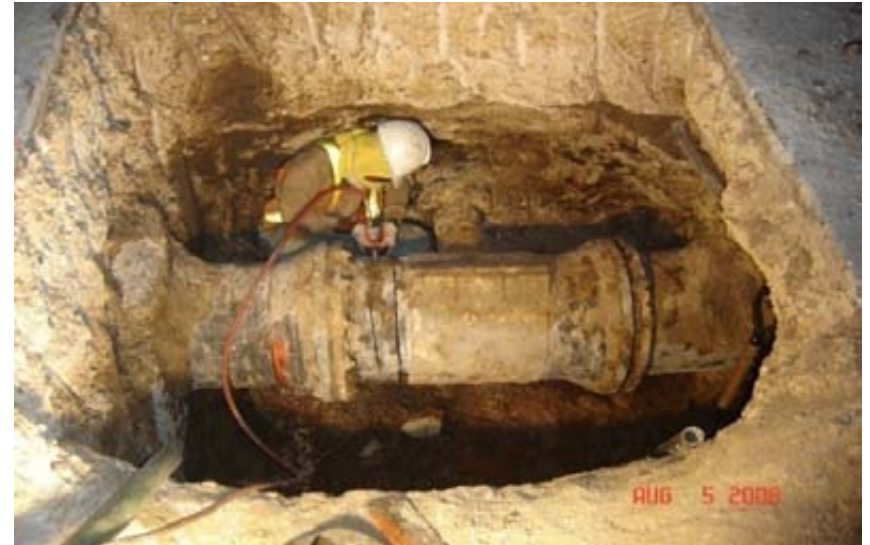
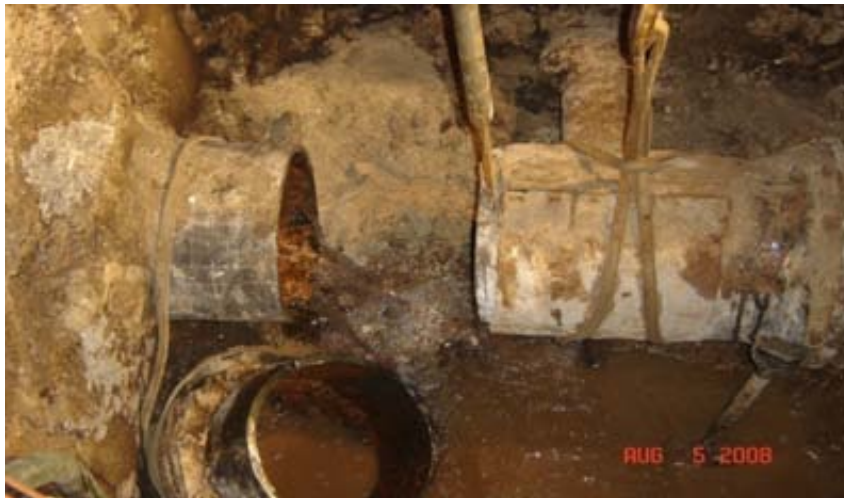
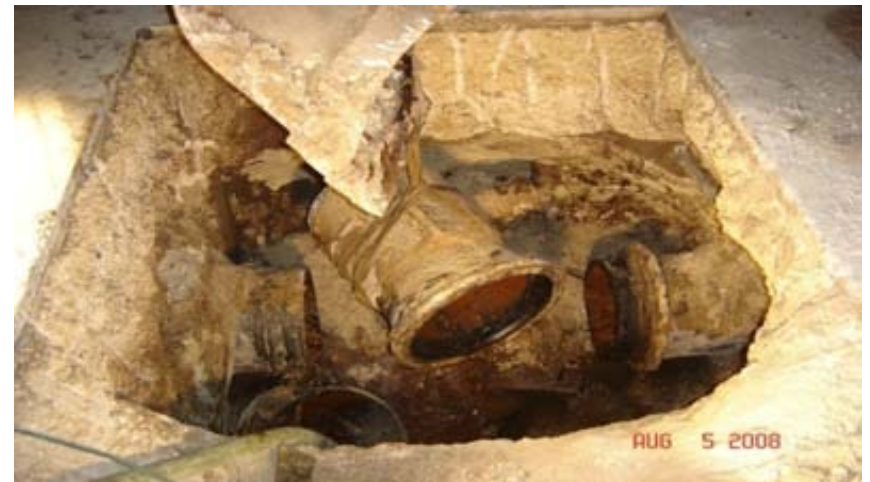
Butterfly Valve Installation—18" Ø Butterfly Valve
As Perdido

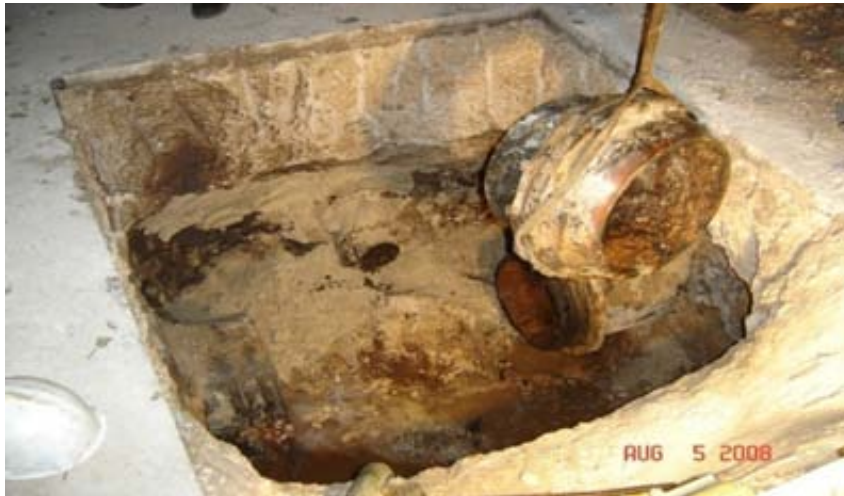
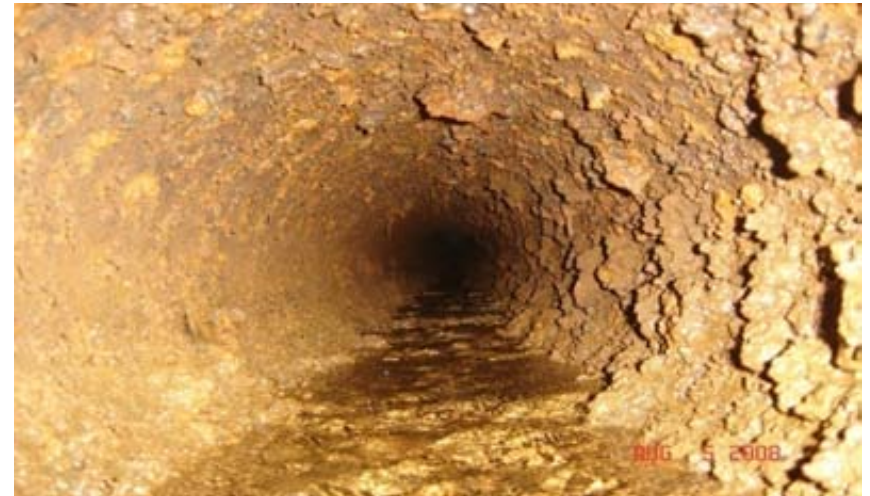
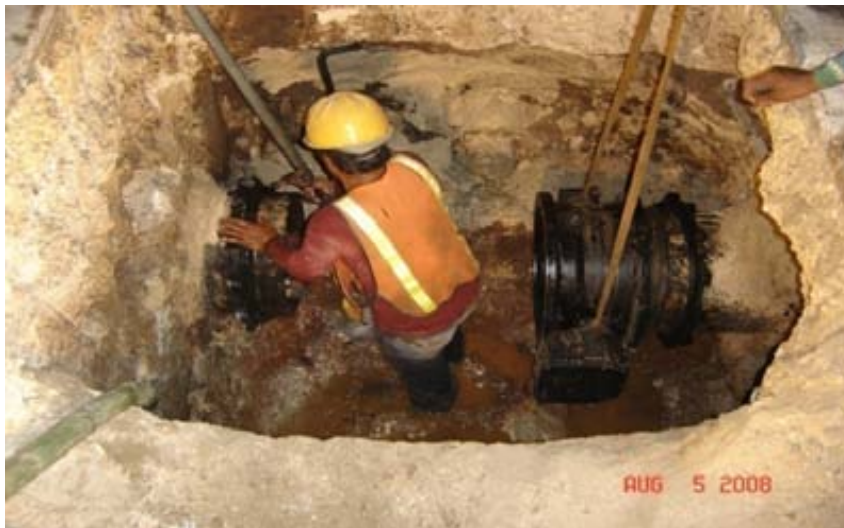
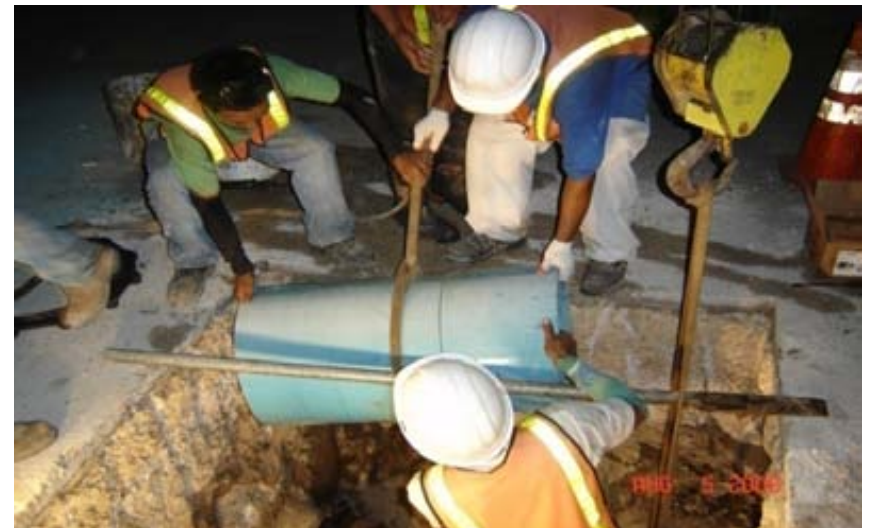
Butterfly Valve Installation—18" Ø Butterfly Valve
As Perdido

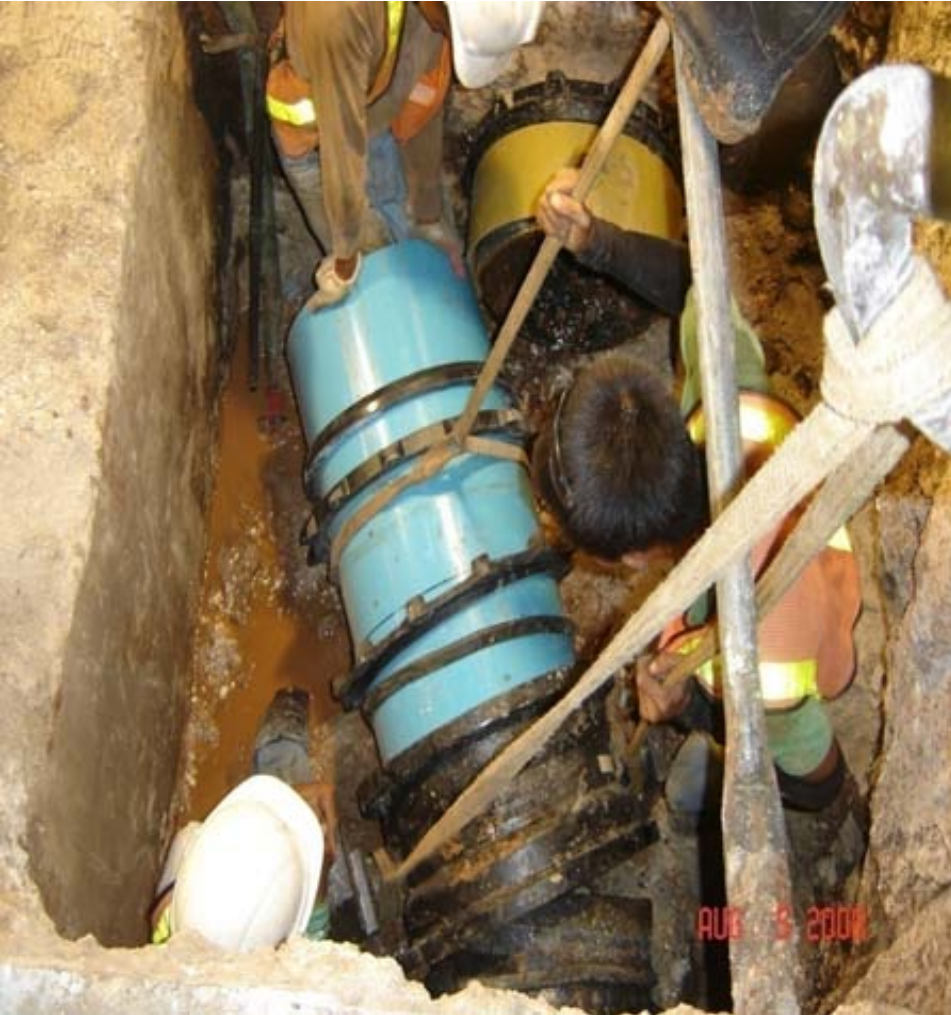
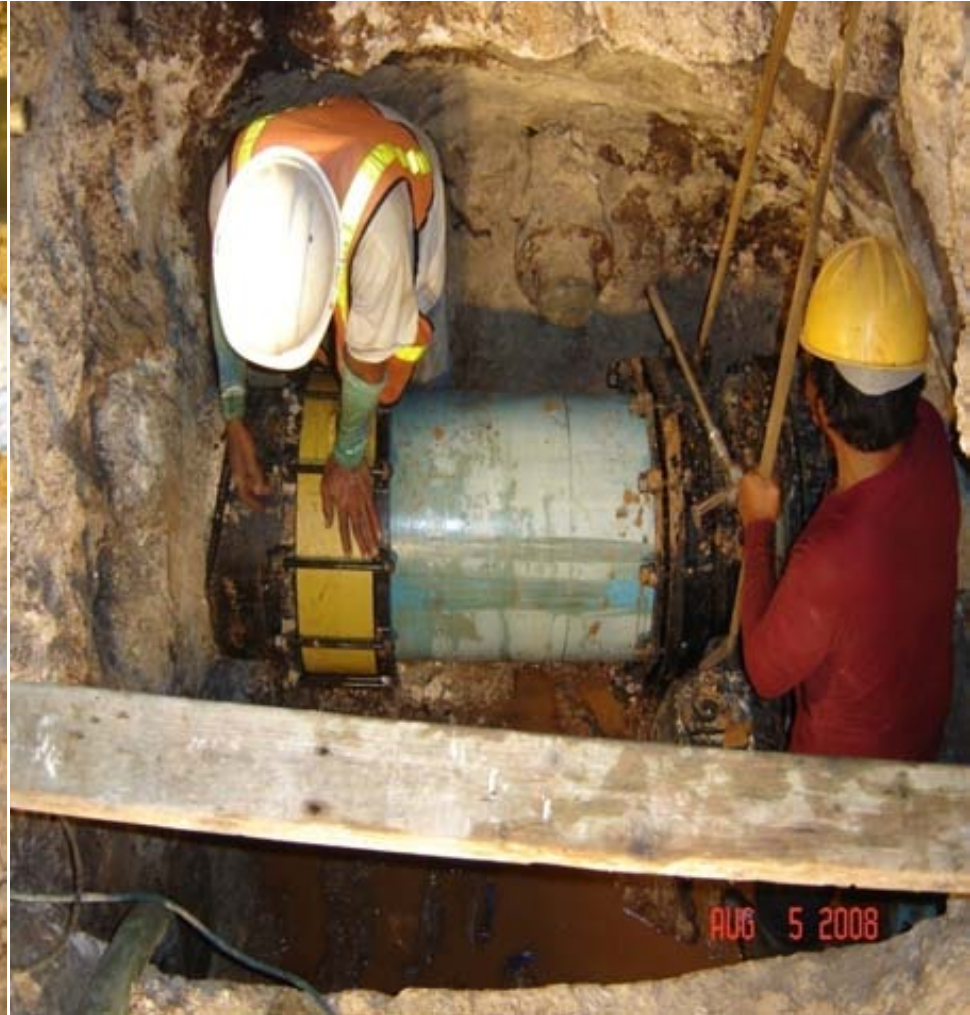
Butterfly Valve Installation—18" Ø Butterfly Valve
As Perdido

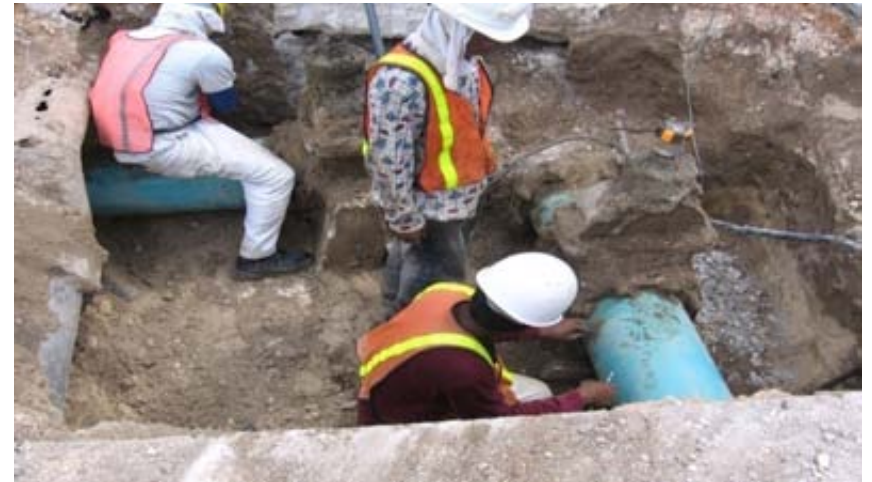
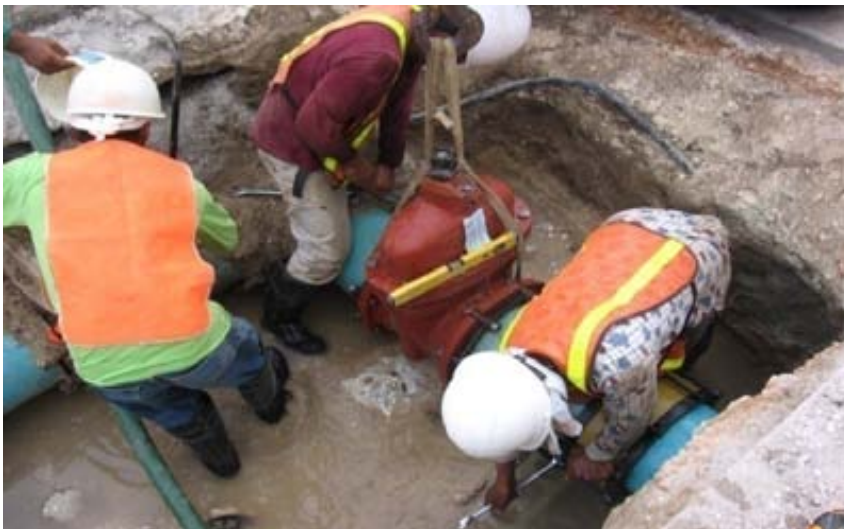
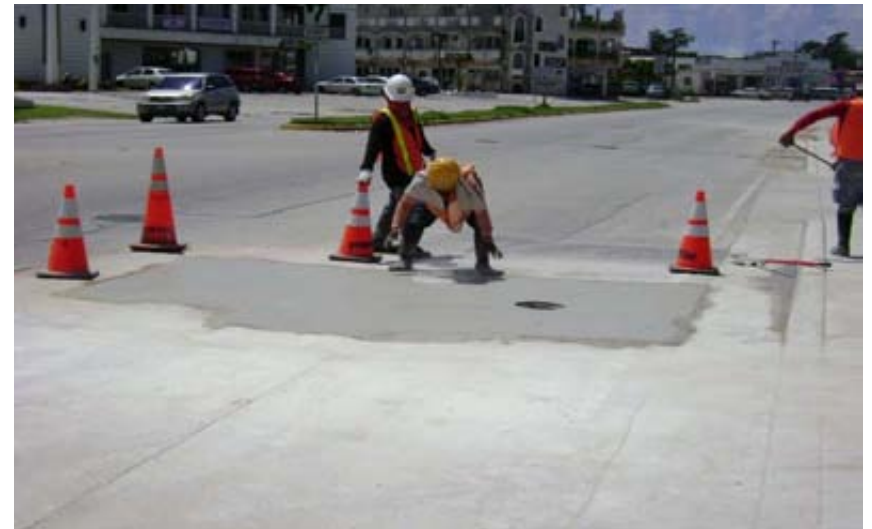
Gate Valve Replacement –12" Ø Gate Valve
As Perdido
